CDW ENGINEERING
CONSULTING ENGINEERS

March 22, 2024

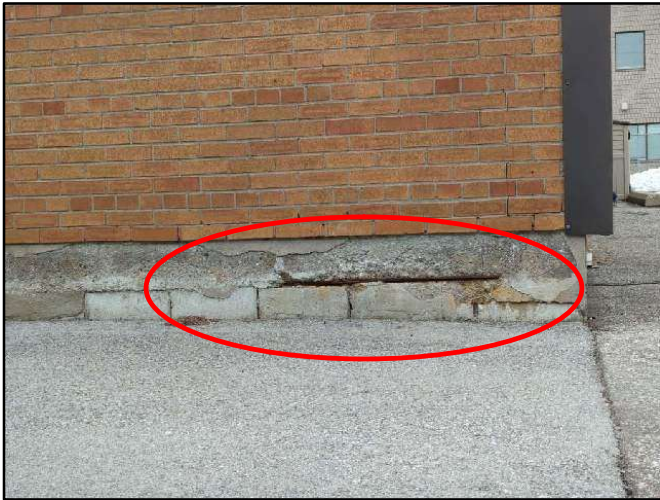
Photo 1. Deteriorated parging, localized spalling of the floor slab edge and exposed horizontal reinforcement at the northeast corner of the building.

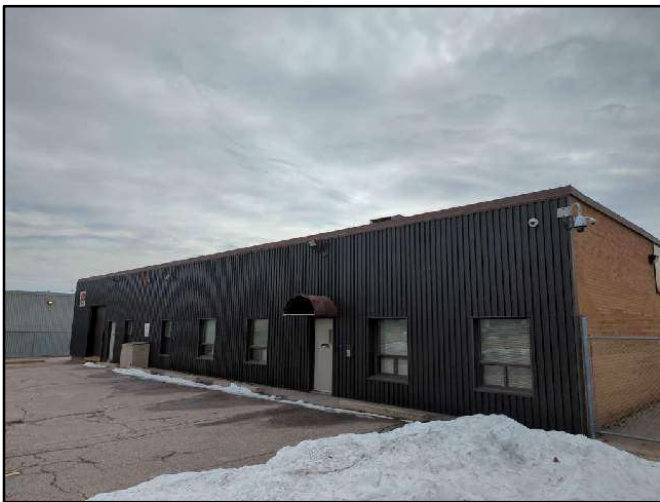
Photo 2. North elevation.

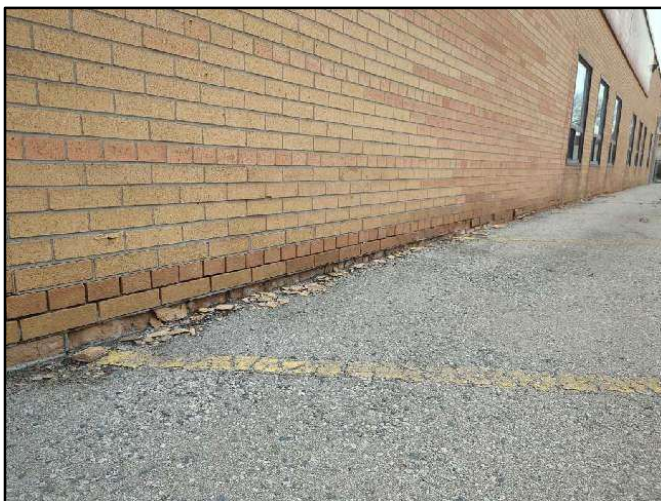
Photo 9. Brickwork at grade that requires repair at the northwest corner of the building.

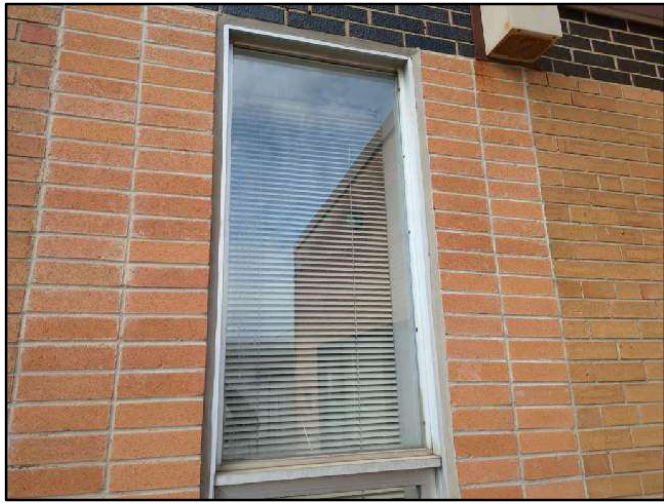
Photo 10. Example of a cracked window.

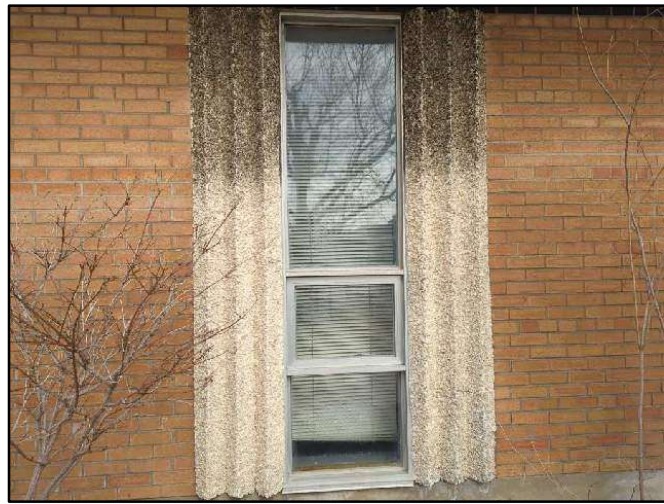
Photo 11. Example of a window with a lost seal. Note the condensation between the glazing.

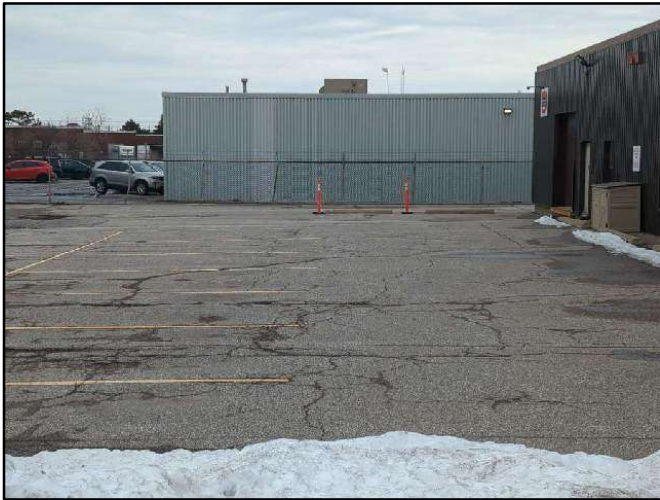
Photo 22. Example of cracking in asphalt paving at the north side of the property.

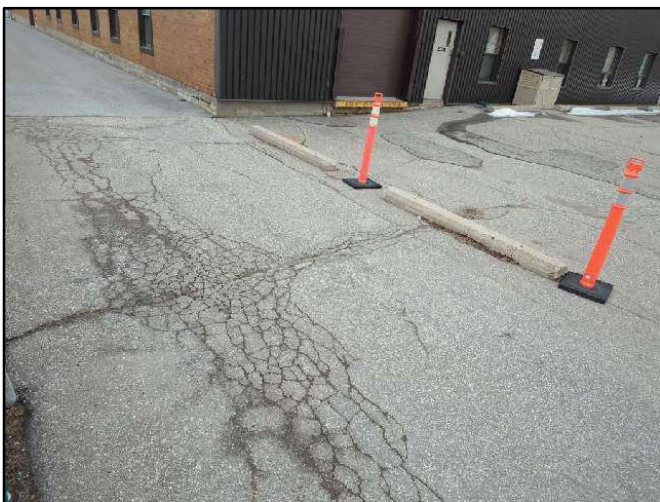
Photo 23. Example of surface deterioration of the asphalt pavement at the north side of the property.

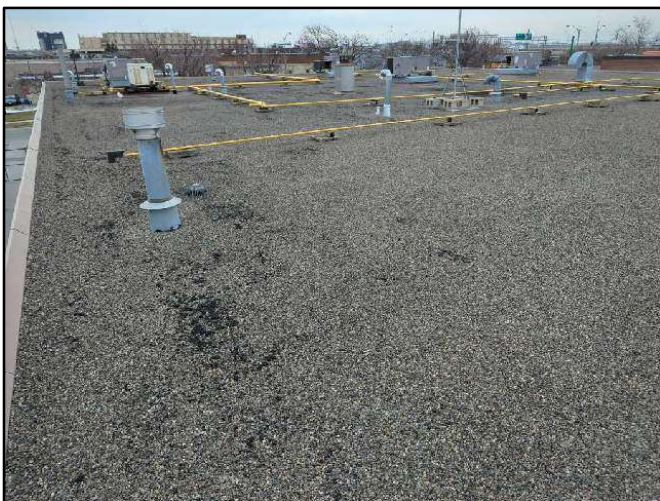
Photo 24. Overview of the built-up asphalt and gravel membrane on the upper roof level.
